Ground-Hornbills & Window-Breaking

THE SOLUTIONS: Please contact us for stockists or more information

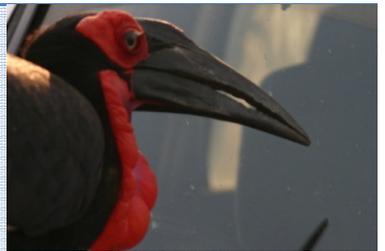
Option	Pros & Cons	
<p>Safety Glass: Two sheets of glass with a layer of adhesive between.</p>	<ul style="list-style-type: none"> ✓ 100% Ground-Hornbill proof. ✓ Permanent solution. ✓ No difference in visibility between this and standard glass so most attractive option ✗ More expensive (35%) than standard glass

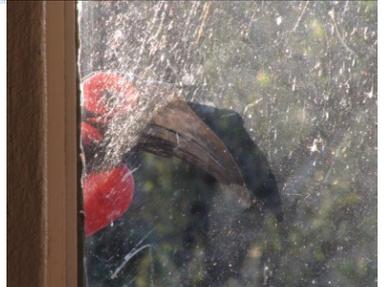
<p>Plastic glass: Polycarbonate plastic or acrylic Perspex can be installed in place of standard window glass.</p>	<ul style="list-style-type: none"> ✓ 100% Ground-Hornbill proof ✓ Permanent solution. ✓ No difference in visibility between this and standard glass. ✗ Can get scratched easily but can easily be removed by polishing with a cream or liquid polish like Brasso.

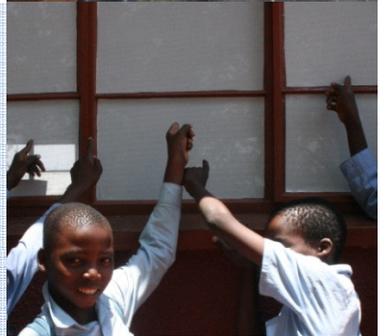
<p>Contravision: Unprinted perforated vinyl film (as used in advertising on shop fronts, busses and motor rear windows)</p>	<ul style="list-style-type: none"> ✓ 100% Ground-Hornbill proof ✓ Permanent solution ✓ No difference in visibility between ✗ Can get scratched

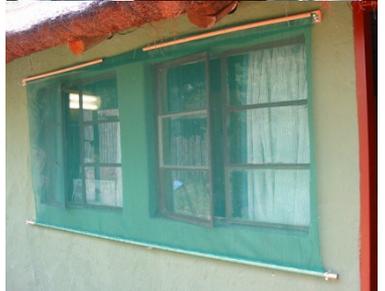
<p>Shade cloth: Shade cloth clipped to an external frame.</p>	<ul style="list-style-type: none"> ✓ 100% Ground-Hornbill proof ✓ Temporary or Permanent solution. ✓ This can be removed when the building is unoccupied as birds are less likely to visit (assuming they are not being fed). ✓ Cheap ✗ More attractive options exist for lodges.

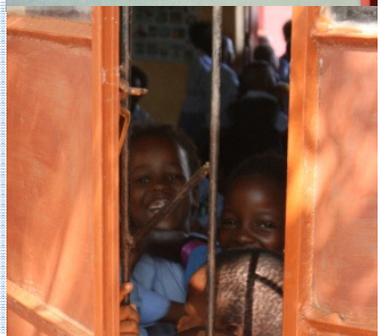
<p>Ash: Smear ash mixed with water on the glass and when it dries the windows are opaque. This mixture can then easily be washed off when no longer needed.</p>	<ul style="list-style-type: none"> ✓ 100% Ground-Hornbill proof ✓ Temporary solution. ✓ This can be removed when the building is unoccupied as birds are less likely to visit (assuming they are not being fed). ✓ Cheap/ Free. Great for rural schools. Children can apply the mixture before going off for school holidays.

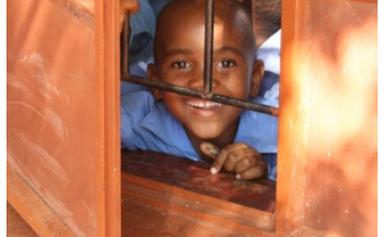
<p>Paint: Instead of using ash the targeted windows can be painted with cheap paint.</p>	<ul style="list-style-type: none"> ✓ 100% Ground-Hornbill proof ✓ Permanent solution. ✓ Cheap. ✗ Difficult to do neatly thus is a less attractive option. The paint also makes the rooms dark.
